INFORMATION NOTICE

Attention: JLG Product Owner
Subject: *Additional Information Regarding Notice IN # 112F1A*
Date: *XX April 2014*

Procedure: Wheel Drive Hub Assembly Inspection

**Model(s): JLG Boom Lift, Model 400S series, 450A series and 510 series
(Reference JLG P/N 2780267 & 2780268)**

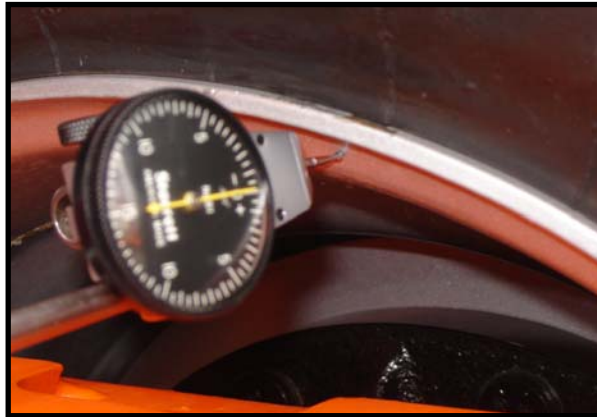
1. Visually inspect the drive hub assemblies for oil leakage.
2. Inspect the drive hub assembly for end play:
 - a. With the machine secured, lift one wheel or axle off the ground, locate dial indicator with magnetic base on frame next to spindle (12:00 location) and indicator on rim (12:00 location) (inboard side of wheel). Reference the attached photograph.

- b. Position hands on the tire at 3:00 & 9:00 locations, push straight in and then pull straight out on tire to observe any end play movement.
 - c. Anticipated movement is 0.025mm – 0.305mm (0.001 inch – 0.012 inch).

3. Inspect drive hub clearance:
 - a. With the machine secured, lift one wheel or axle off the ground, locate dial indicator with magnetic base on frame next to spindle (12:00 location) and indicator on rim (12:00 location) (inboard side of wheel). Reference the attached photographs.

- b. Position hands on the tire at 12:00 & 6:00 locations, rock the tire back and forth (push at 6:00, pull at 12:00 then pull at 6:00, push at 12:00) to observe any tire/hub movement or wobble. Repeat procedure with hands at 3:00 & 9:00 positions.

- c. Anticipated movement is +/- 1.52mm (+/- 0.060 inch).

4. Remove the magnetic oil drain plug and inspect for metal shavings. Ensure that any oil that drains from the drive hub is caught and properly disposed of.
5. If the measurements from Steps 2 & 3 are outside the allowable tolerances or if metal shavings are found in the gear oil of the drive hub, then rebuilding of the hub or replacement is required prior to returning the unit to service.
6. If rebuilding the wheel drive hub, please reference the Service & Maintenance Manual for rebuild instructions. For ordering a hub bearing replacement/rebuilding kit, please reference below. Reference the Illustrated Parts Manual for any additional components that may be required.

7. If all of the measurements are within the allowable tolerances and metal shavings are not discovered in the gear oil of the drive hub, then ensure there is no visual damage to the wheel assembly. If no visual damage is observed, the unit can be returned to service.

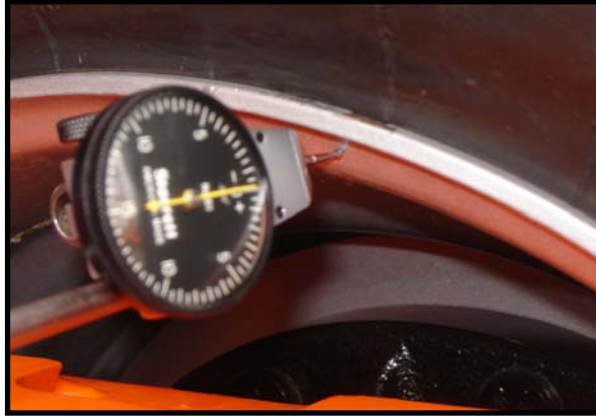
1. Visually inspect the drive hub assemblies for oil leakage.
2. Inspect the drive hub assembly for end play:
 - a. With the machine secured, lift one wheel or axle off the ground, locate dial indicator with magnetic base on frame next to spindle (12:00 location) and indicator on rim (12:00 location) (inboard side of wheel). Reference the attached photograph.

- b. Position hands on the tire at 3:00 & 9:00 locations, push straight in and then pull straight out on tire to observe any end play movement.
 - c. Anticipated movement is 0.025mm – 0.305mm (0.001 inch – 0.012 inch).

3. Inspect drive hub clearance:
 - a. With the machine secured, lift one wheel or axle off the ground, locate dial indicator with magnetic base on frame next to spindle (12:00 location) and indicator on rim (12:00 location) (inboard side of wheel). Reference the attached photographs.

- b. Position hands on the tire at 12:00 & 6:00 locations; rock the tire back and forth (push at 6:00, pull at 12:00 then pull at 6:00, push at 12:00) to observe any tire/hub movement or wobble. Repeat procedure with hands at 3:00 & 9:00 positions.

- c. Anticipated movement is +/- 1.52mm (+/- 0.060 inch).
4. Remove the magnetic oil drain plug and inspect for metal shavings. Ensure that any oil that drains from the drive hub is caught and properly disposed of.
5. If the measurements from Steps 2 & 3 are outside the allowable tolerances or if metal shavings are found in the gear oil of the drive hub, then rebuilding of the hub or replacement is required prior to returning the unit to service.
6. If rebuilding the wheel drive hub, please reference the Service & Maintenance Manual for rebuild instructions. For ordering a hub bearing replacement/rebuilding kit, please reference below. Reference the Illustrated Parts Manual for any additional components that may be required.

7. If all of the measurements are within the allowable tolerances and metal shavings are not discovered in the gear oil of the drive hub, then ensure there is no visual damage to the wheel assembly. If no visual damage is observed, the unit can be returned to service.
