Manual task case study: Moving gas bottles – Monarch Building Systems

Monarch Building Systems Pty Ltd manufactures and supplies building products for residential construction. It currently employs 22 workers.

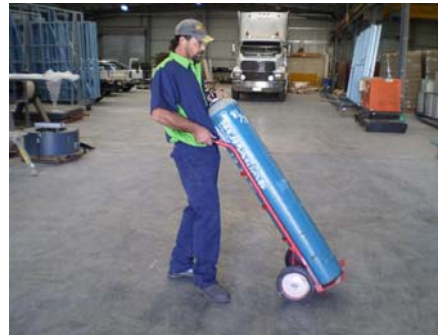
Figure 1 – old gas trolley

Using the PERforM risk assessment worksheet, workers found high levels of exertion and awkward postures in the upper limbs and back when using trolleys to retrieve or return cylinders from the storage area (Figure 1).

The load required high exertion because of the cylinders' weight - some are quite tall and weigh in

excess of 50 kilograms. They were also difficult to control and balance...

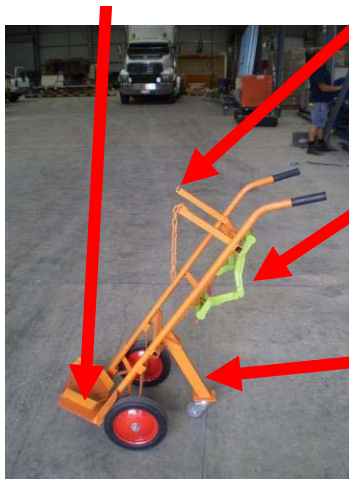
Sides to secure cylinder to shelf of trolley.

Holding arms with chain to secure cylinder to trolley.

Hook for storing the clamp/lifting device.

Stabilising leg with pivot wheel to relieve weight and aid control.

Figure 2 – trolley modifications

- a stabilising leg with a swivel wheel to the back of the trolley
- walled sides that secure the gas bottle on the bottom of the trolley
- holding arms that secure the gas bottle at the top
- a chain (strap) that holds the bottle in the securing arms
- a hook to hold the clamp/lifting device.

The third wheel spread the weight of the load over a larger base so less force was required to move the trolley and the cylinder was more stable, reducing posture risks. (Figures 2, 3 and 4).

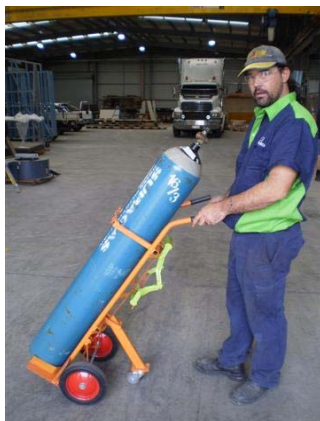
Figure 3 – small trolley

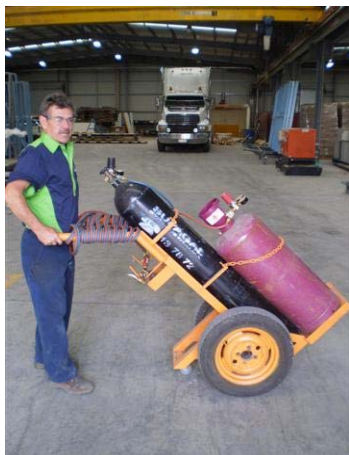
Figure 4 – heavy duty trolley for oxy set
