## Findings report:

### Phase one audits of engineered stone benchtop fabricators in South East Queensland

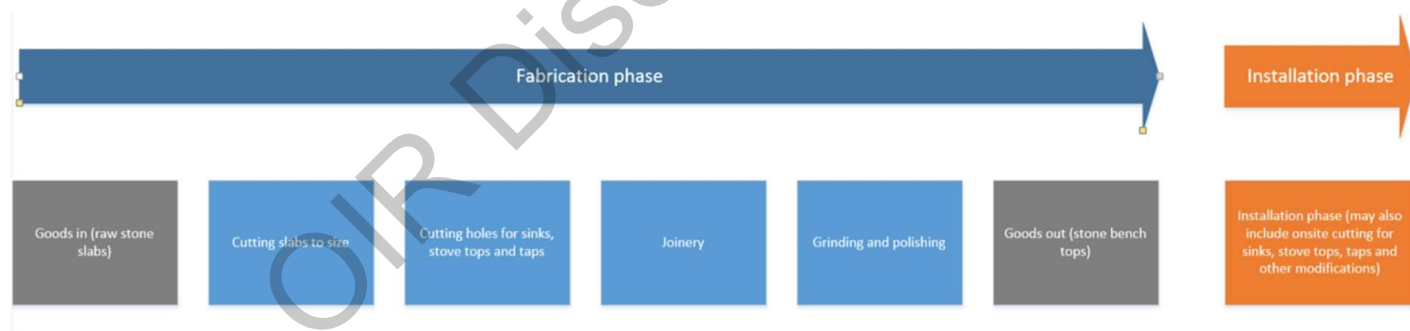
Figure 1 - Stone benchtop fabrication and installation process (general)

Figure 1 (below) provides a general description of work flow in the stone-benchtop fabrication industry. Each workplace varied slightly depending on work organisation, staff and layout.

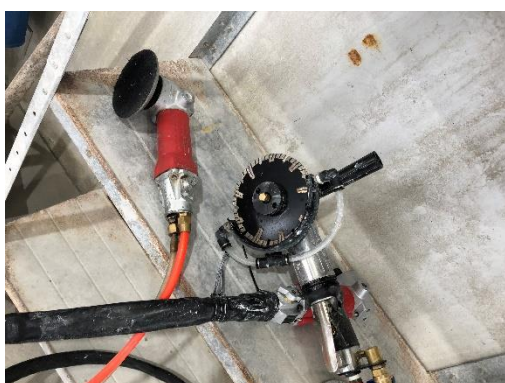
*Figure 2 - Photo of a pneumatic polisher and grinder with water feeds.*

Water suppression was the primary engineering control used to manage dust at all workplaces visited. Examples of water suppressed equipment included water attached bridge saws, water-fed routers, waterjet cutting machines, water suppressed polishing machines and water attached grinders and polishers.

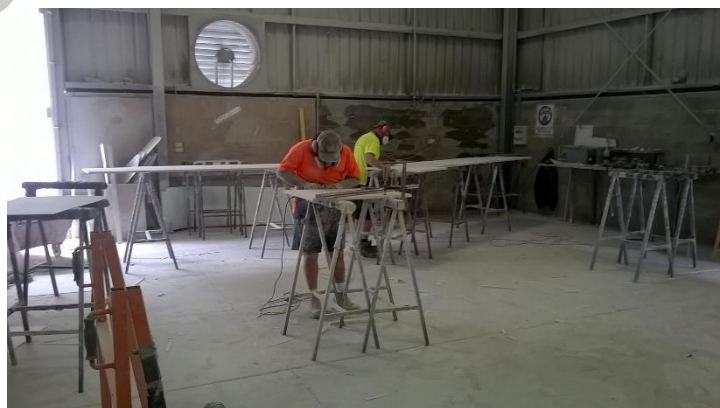
Only one of the ten workplaces conducted dry cutting as a primary process. They complete sink and stovetop cut-outs, dry grinding, edge grinding and bevelling without water suppression or local exhaust ventilation. This was replaced with wet cutting and grinding methods after enforcement action. Five of the ten workplaces self-reported that they used dry cutting previously to fabricate benchtops.

*Figure 3 - Photo of two workers conducting dry cutting. Dust is visible on the floor and workers clothing. Enforcement action was taken to prohibit the process until exposure risks were managed. Photo by WHSQ.*

None of the workplaces visited sanded or polished stone dry. Dry cutting, grinding and polishing is unnecessary and can be readily substituted for wet methods.

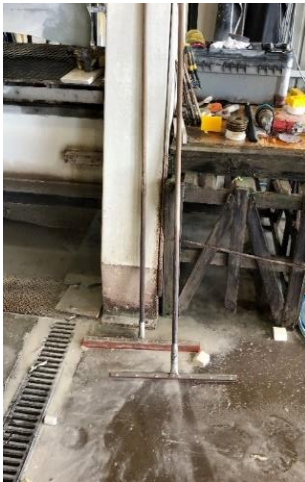
A slurry of stone and water was created by wet processes. All the sites visited had some form of curbing and channelling installed to contain and remove the slurry. In many cases slurry was allowed to dry on the floor and other surfaces leaving deposits of dry stone dust that could be disturbed and made airborne. The use of fans in the workplace for cooling or ventilation was likely to increase the rate in which wet surfaces dried.

*Figure 4 - Instead of dry sweeping, squeegees were commonly used to move stone slurry into floor grates.  
Photo by WHSQ*

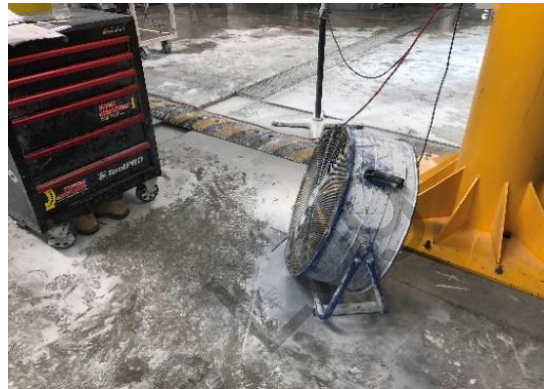
It is likely that this poor housekeeping would increase the level of airborne RCS within the workplace and contribute to the exposure levels of all fabrication workers. Poor cleaning methods included the use of compressed air, dry sweeping or high pressure water. Poor cleaning may have generated airborne dust causing exposure.

*Figure 5 - Photo of dust deposits allowed to dry. Fans may have assisted in drying wet surfaces leaving dry stone deposits.*

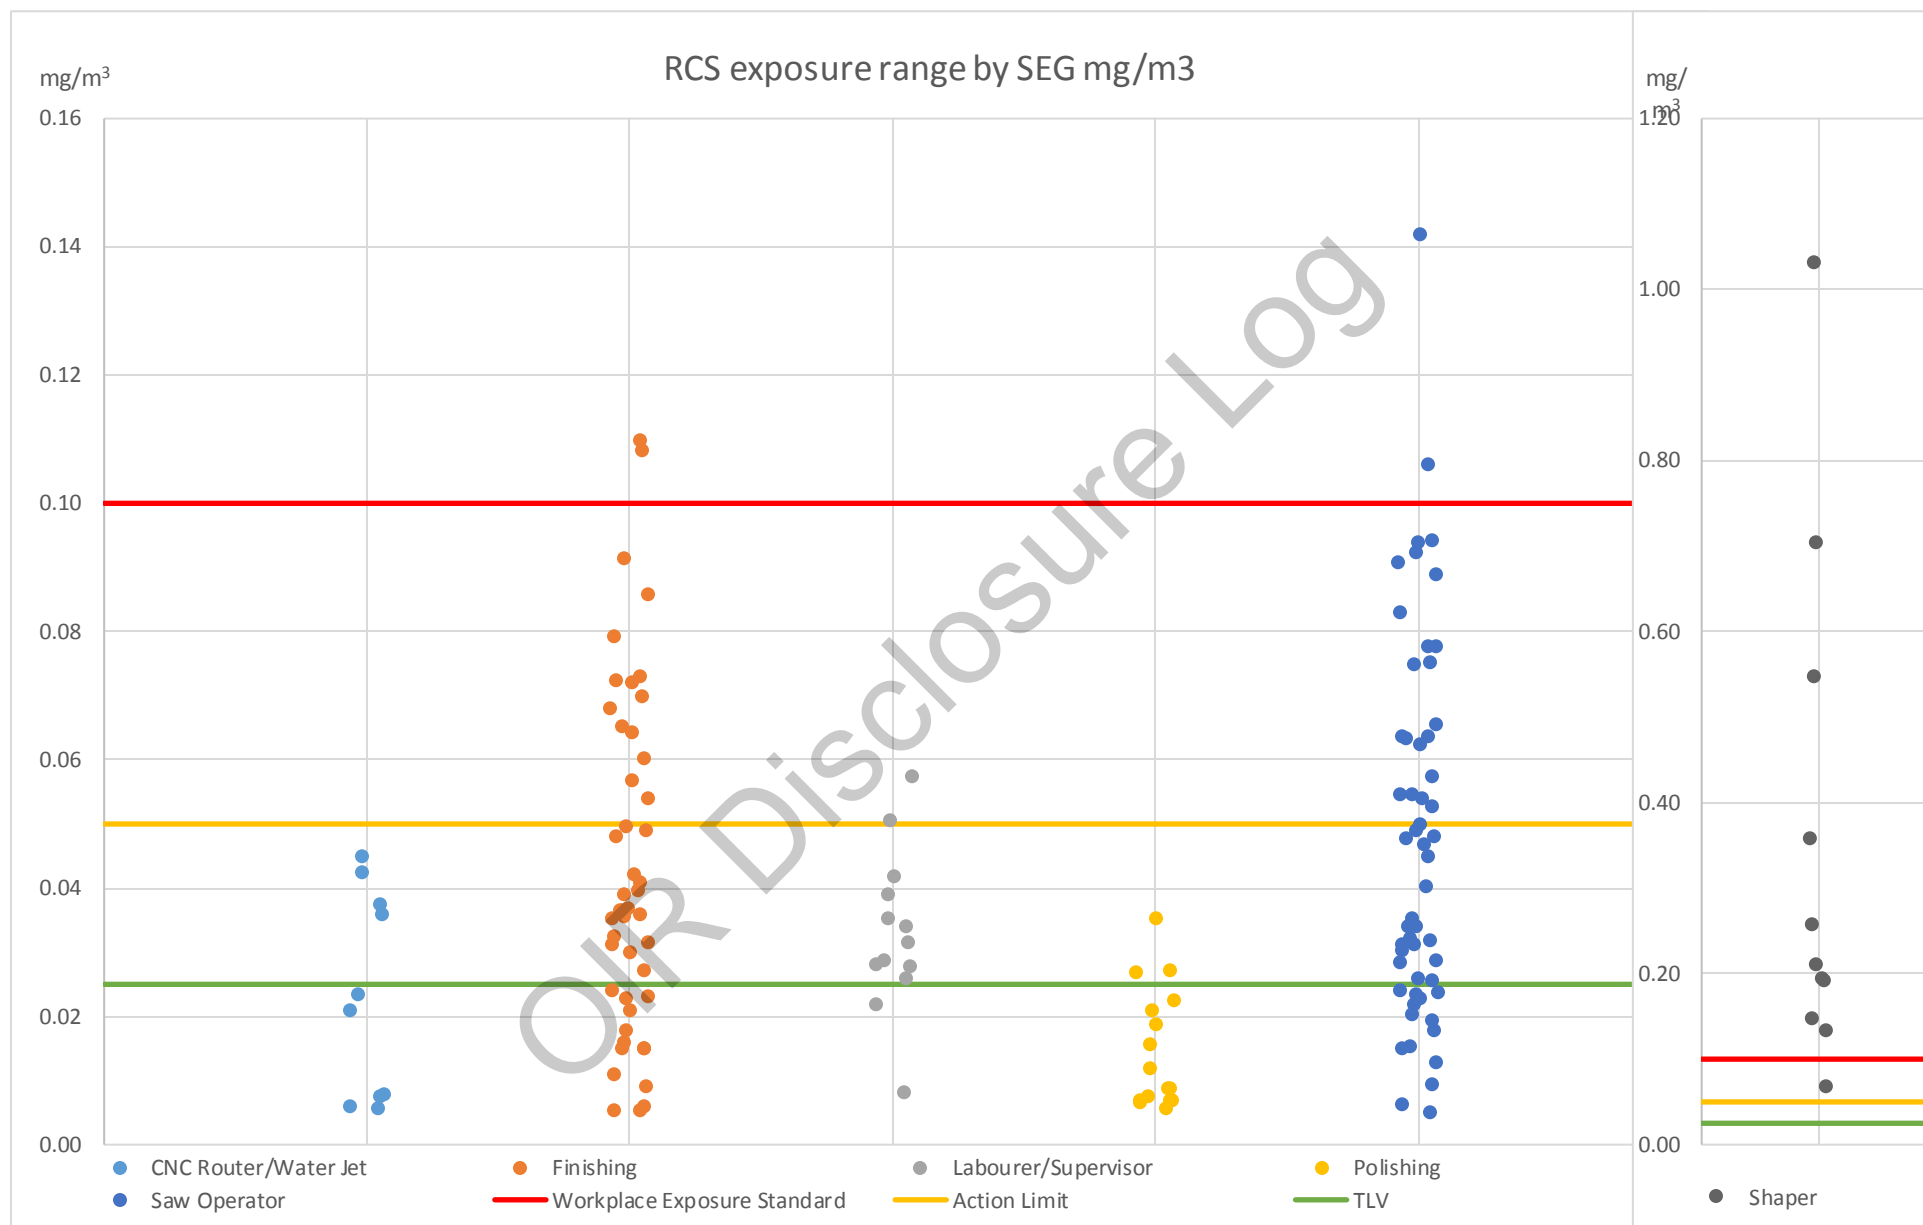
Figure 6 - Graph of individual exposures (8hr TWA) for each SEG

Ten individual measured concentrations exceeded the WES for the Shapers SEG, compared with four for every other SEG combined (two in Finishing, two in Saw operators).

The majority of individual measured concentrations for the CNC Router/Water Jet operators, Labourer and Supervisor and Polishing SEGs are below the orange line (action level).

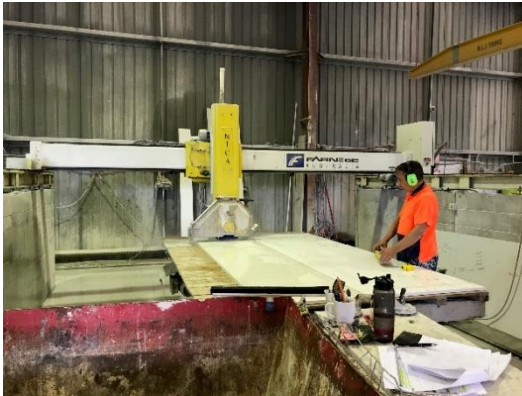
Saw operators used bridge or mitre saws to cut slabs to size. All saws observed were water suppressed, with water feeds directed at either the blade, slab, or both. The machines could either be manual or computer controlled.

*Figure 7- Older manual bridge saws without any means to prevent workers from standing close to the process when operating the saw. Photo by WHSQ.*

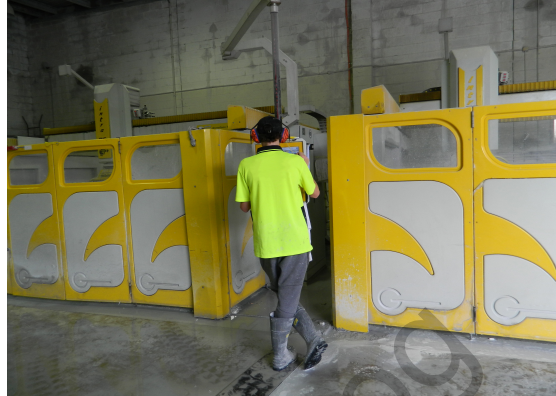
*Figure 8 – Newer CNC bridge saws were fitted with bay doors. Photo by WHSQ.*

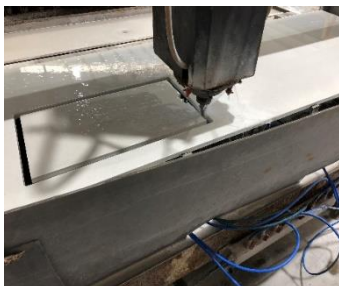
*Figure 9 - CNC router without plastic shrouding to contain dust and water mist. Photo by WHSQ.*

- containing or capturing water mist using plastic shrouds, flaps or brush guards around the tool (refer to Figure 9 and 10)
- isolating the worker from the process either through physical barriers like bay doors or through distance
- maintaining water control systems to ensure an adequate flow of water during cutting
- preventing water drying on surfaces.

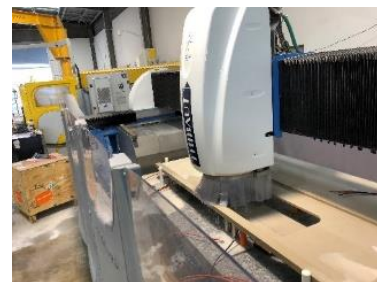
*Figure 10 - CNC router with plastic shrouding. Photo by WHSQ.*
